CONWAY ELECTRIC DAM
MA 00463

PHASE I INSPECTION REPORT
NATIONAL DAM INSPECTION PROGRAM

DEPARTMENT OF THE ARMY
NEW ENGLAND DIVISION, CORPS OF ENGINEERS
WALTHAM, MASS. 02154

MARCH 1981

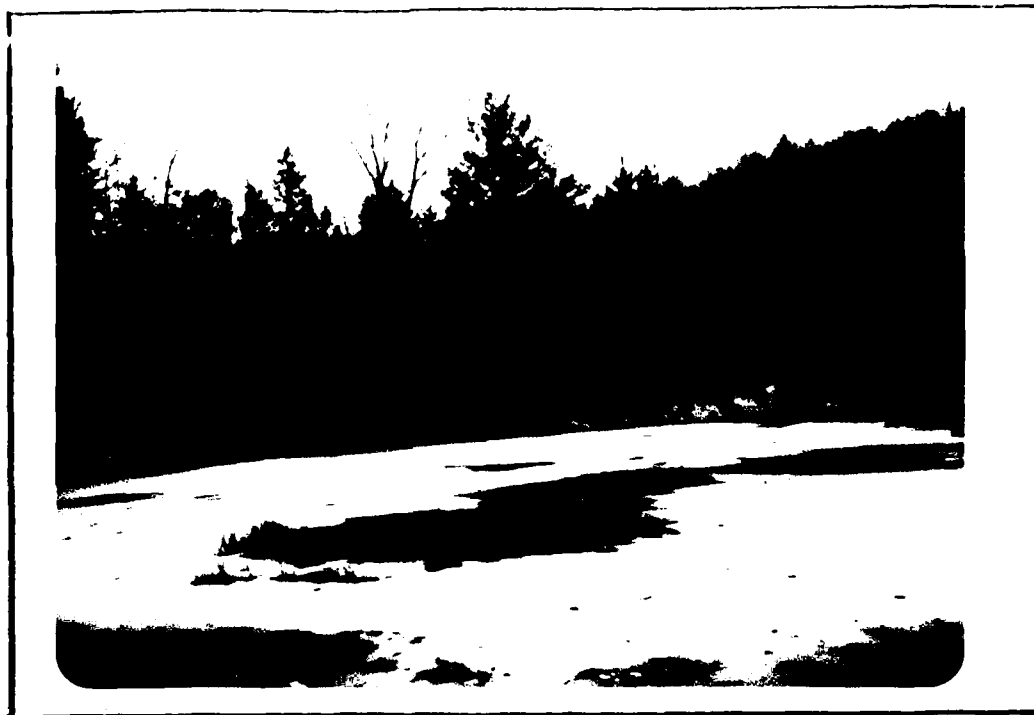
1. SILT FILLED IMPOUNDMENT WITH PENSTOCK ENTRANCE ON THE LEFT AND THE LEFT ABUTMENT OF THE DAM ON THE RIGHT. (12/2/80)
